**Survey Report Of  
O. S. V. “JHW Amethyst”**

## JHW Amethyst

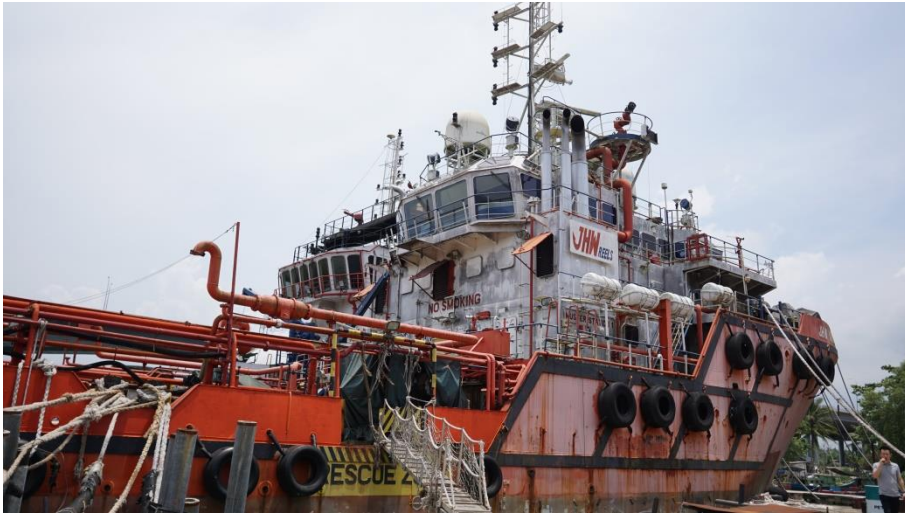
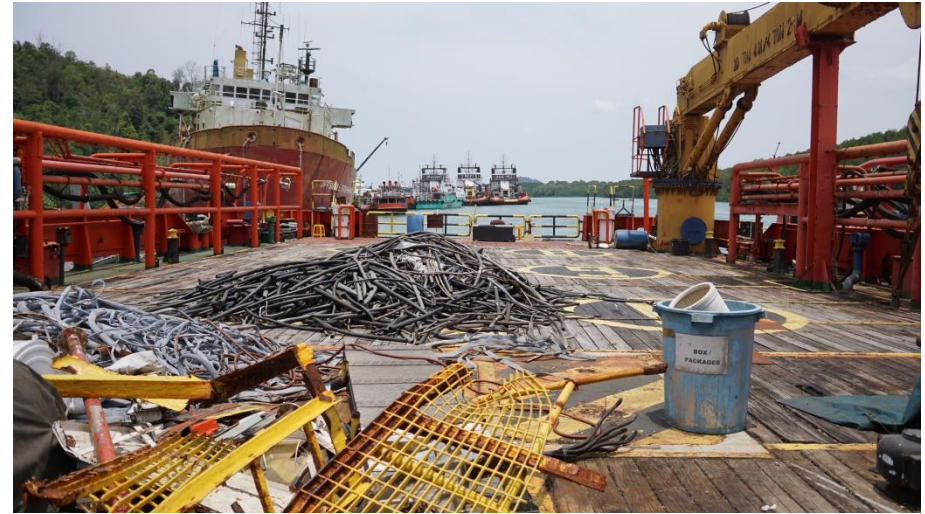
### Vessel Exterior

- The exterior of the Vessel is in a deteriorating condition due to lack of maintenance for a long period, however, the hull plating of the Vessel appeared to be free from major damages. The paintwork of the Vessel painting is fading and coating is filled with rusty patches.
- At the forward section of the main deck, several foreign items and piles of wire insulation were scattered and found on the main deck looking aft of the Vessel.
- In addition, the emergency rescue boats and life rafts were removed from forecastle deck and boat deck of the Vessel,

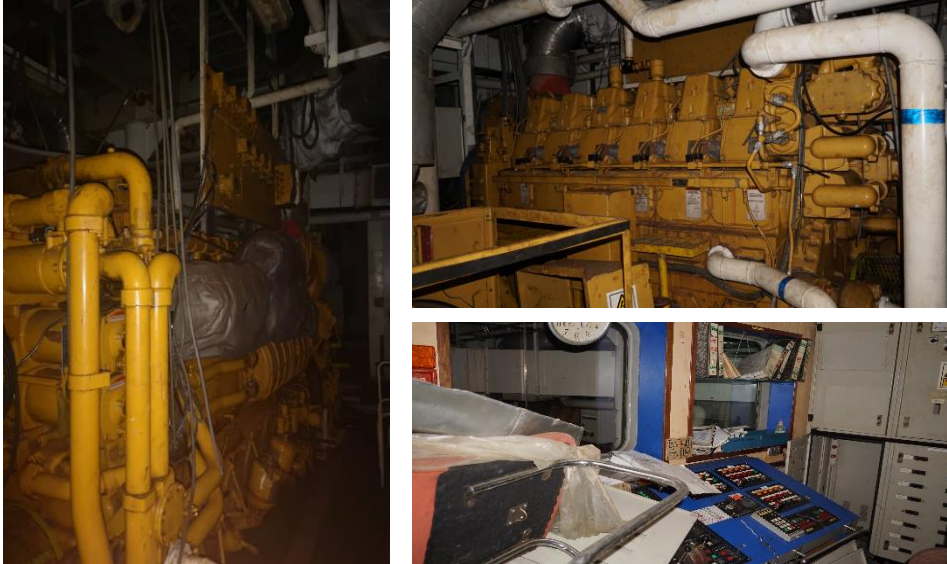
### Main Engines & Engine Room

- From visual inspection, the two (2) main engines units (Caterpillar 3606) fitted with CP Propellers were noted to be intact and free from any major fuel or lube leakages.
- It was sighted that the chequered floor boards were loose due to attempts for removal of mechanical parts underneath.
- The engine control room ("E.C.R") is in a messy condition with engine control consoles covered with dispersed documents and furniture.
- The ship control panel in the E.C.R was found damaged and it has to be repaired to become functional in order for the engineers to monitor the critical equipment to ensure the stability of the Vessel.

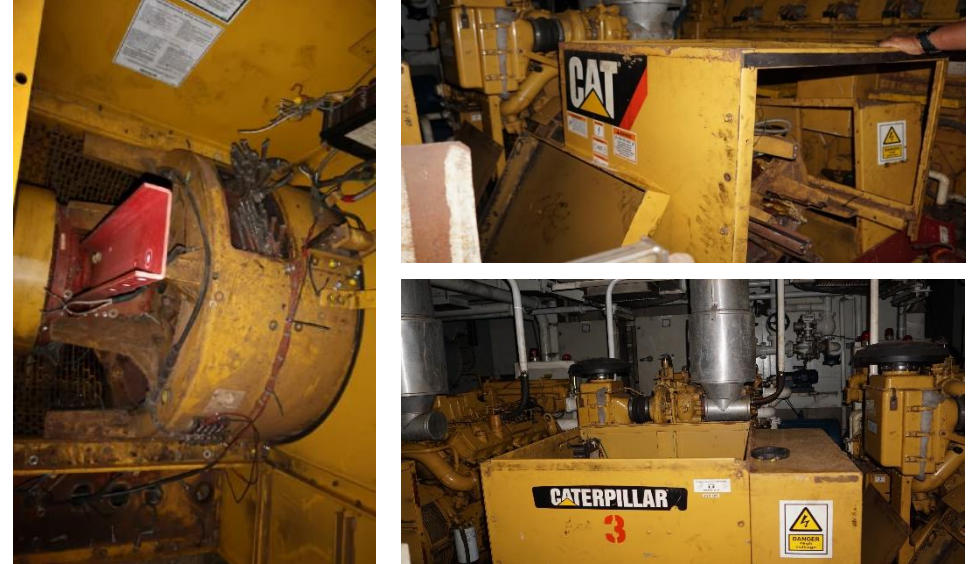
### Generators

- There are three (3) units of main generators (Caterpillar 3412) to drive their respective alternators (Leroy Somer ARCB 594, A.C.). It was noted that there were missing key electrical components from the alternators.
- There is also one (1) unit of Caterpillar C44 and two (2) units of shaft alternators (Leroy Somer LSAM 501S4) which appeared to be out of service with panels opened and some parts removed from the alternators.
- The alternators need to be rewound and all missing electrical parts need to be reinstalled in order for the alternators to be in operational condition. The aforementioned problem must be rectified as the Vessel is required to generate electricity to power up the auxiliary machineries.

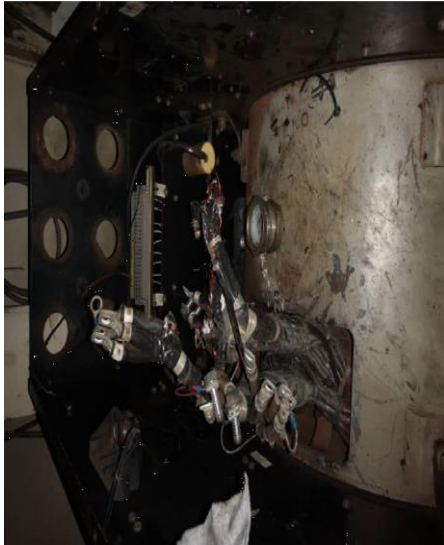
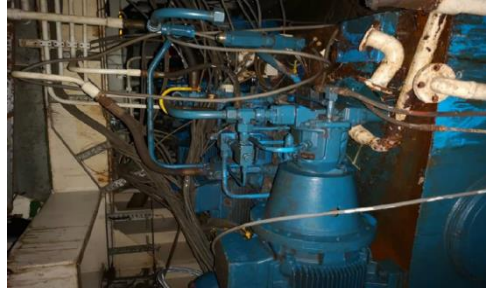
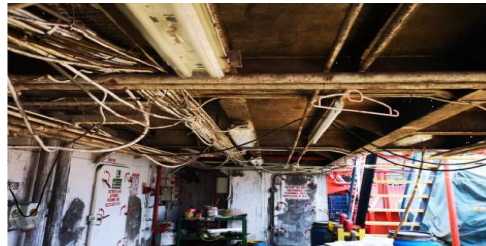
#### Electric Cabling

- Resulting from our inspection of the engine room spaces, electrical cables were found missing, and panel covers were disassembled from the ship control panel. The electrical switchboards, distribution panels and their auxiliary installations were partially stripped and left on the ground.
- As such, cabling work must be fixed and certified by the surveyors society.

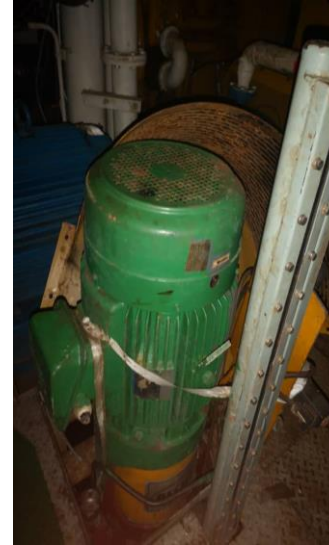
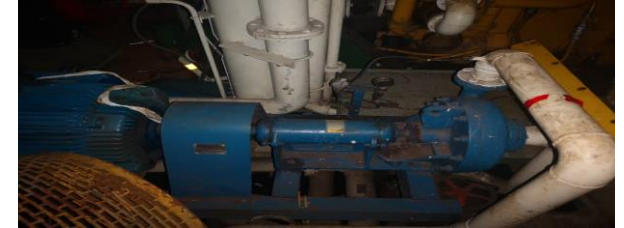
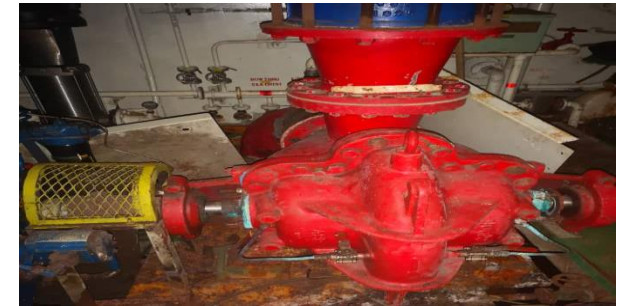
#### Fire Fighting Equipment – Fire Pumps

- In accordance to the Certified Fire Fighting requirements, the Vessel is fitted with fire fighting equipment, i.e. foam monitors, fire pumps and fire detective system and CO2 flooding system.
- There are two (2) units of water foam monitors powered by Fi- Fi fire pumps, two (2) units of GS/ fire pumps, one (1) unit of emergency fire pump, and one (1) set of thorn fire detection system.
- From visual examination, it was noted that the built in fire pumps are intact with no significant damage.

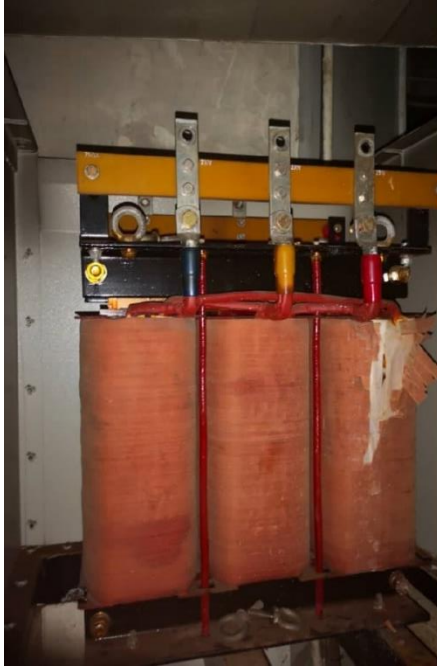
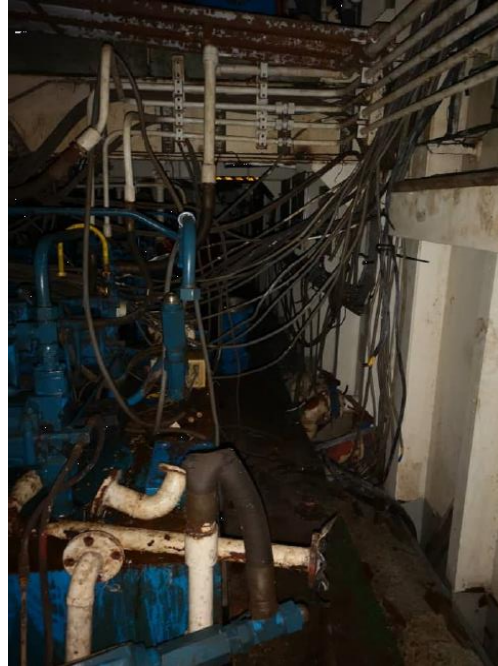
#### Valve and Piping

- There are three (3) units of hydraulic power pack and hydraulic oil coolers where electrical wirings and piping were found cut and damaged during our inspection.
- The hydraulic system must be fixed and replaced to enable the pressurized fluid to power the engines through hydraulic valves.
