**Survey Report Of  
O. S. V. “JHW Amethyst”**

## JHW Amethyst

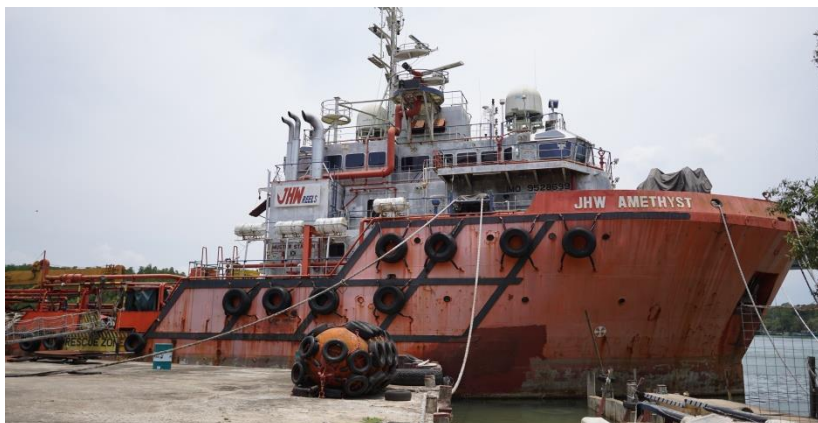
Vessel berthed alongside Asian Jetty, Kemaman, Malaysia

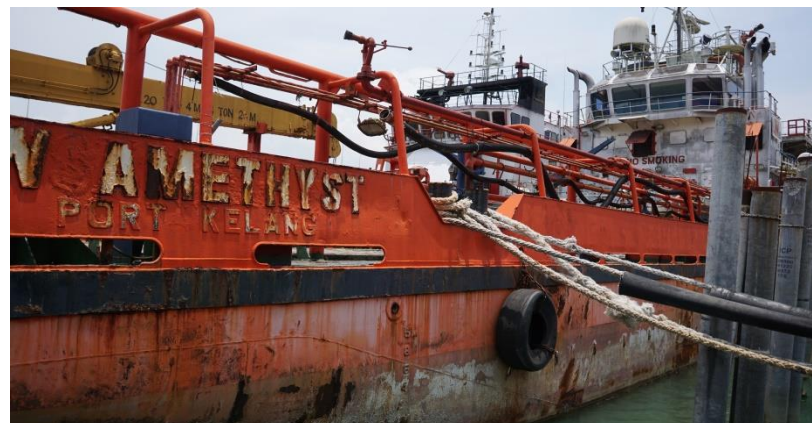
Portside Hull

- The exterior of the Vessel is in a deteriorating condition due to lack of maintenance for a long period, however, the hull plating of the Vessel appeared to be free from major damages. The paintwork of the Vessel painting is fading and coating is filled with rusty patches.
- At the forward section of the main deck, several foreign items and piles of wire insulation were scattered and found on the main deck looking aft of the Vessel.
- In addition, the emergency rescue boats and life rafts were removed from forecastle deck and boat deck of the Vessel,

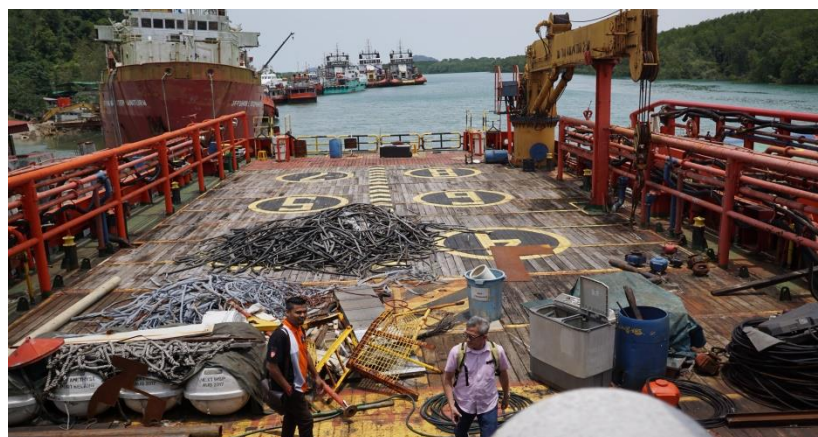
General View of Deck

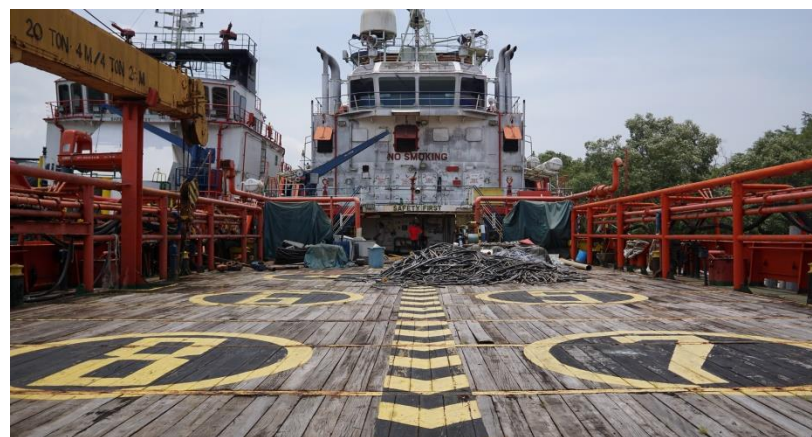
Forward View of Superstructure

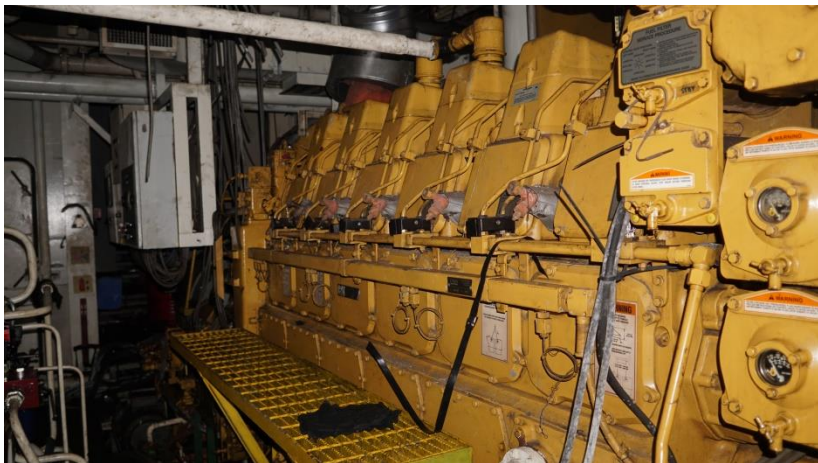
Portside Main Engine

- From visual inspection, the two (2) main engines units (Caterpillar 3606) fitted with CP Propellers were noted to be intact and free from any major fuel or lube leakages.
- It was sighted that the chequered floor boards were loose due to attempts for removal of mechanical parts underneath.
- The engine control room ("E.C.R") is in a messy condition with engine control consoles covered with dispersed documents and furniture.
- The ship control panel in the E.C.R was found damaged and it has to be repaired to become functional in order for the engineers to monitor the critical equipment to ensure the stability of the Vessel.

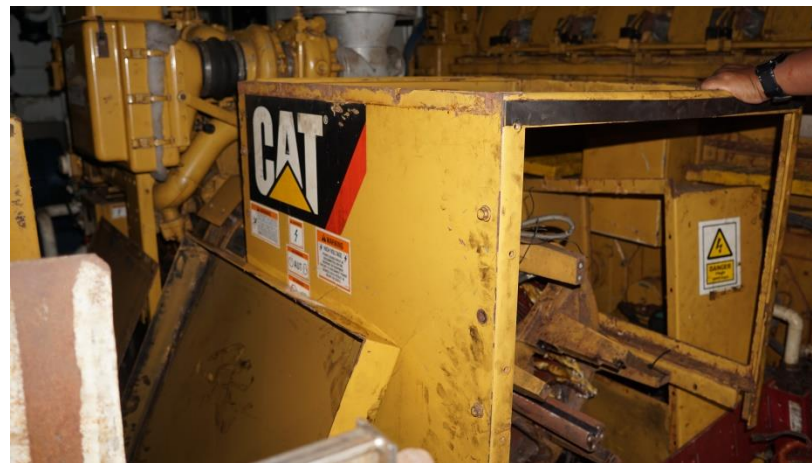
Diesel Generator

- There are three (3) units of main generators (Caterpillar 3412) to drive their respective alternators (Leroy Somer ARCB 594, A.C.). It was noted that there were missing key electrical components from the alternators.
- There is also one (1) unit of Caterpillar C44 and two (2) units of shaft alternators (Leroy Somer LSAM 501S4) which appeared to be out of service with panels opened and some parts removed from the alternators.
- The alternators need to be rewound and all missing electrical parts need to be reinstalled in order for the alternators to be in operational condition. The aforementioned problem must be rectified as the Vessel is required to generate electricity to power up the auxiliary machineries.
